The Slab Jigsaw

Week 9 - report of work for disabled access, toilet and kitchen - 3rd May - 6th May

Gradients and Gravel

Week 8 - report of work for disabled access, toilet and kitchen 25th April - 29th April

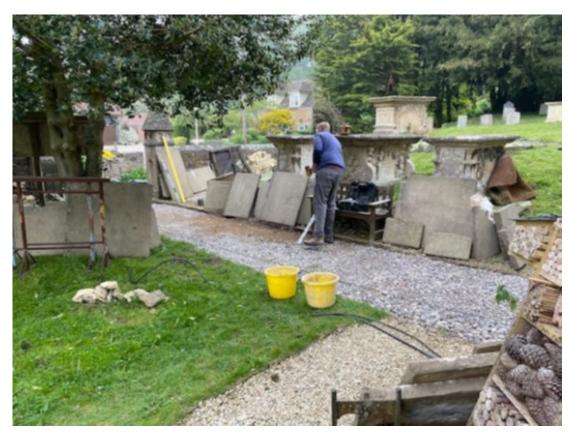
✓ Continuing the work on the approach up to the porch from last week, the stone slabs were re-laid in exactly the same order as they were taken up. Work started on laying them down on a bed of mortar to form a slight ramp up to the porch step.

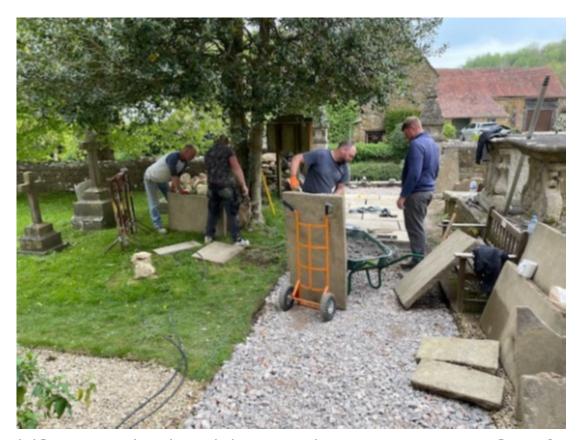
Due to the extreme weight of some of these large pieces of stone, extra hands were needed such that four men were required to take a corner each in order to gently place the slabs in just the right position.

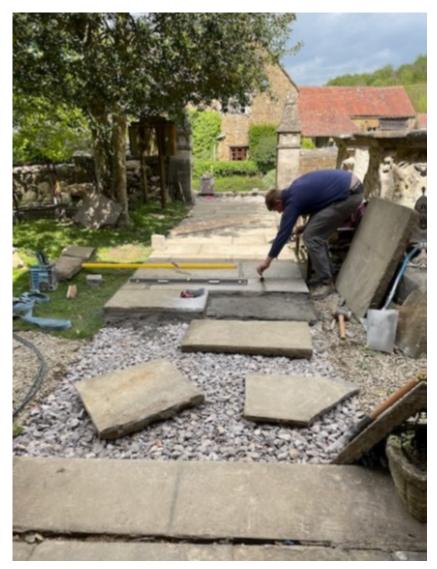
While Jon mixed and barrowed a constant supply of mortar, the slabs were set down, carefully followed by Doug who grouted the joints between each stone.

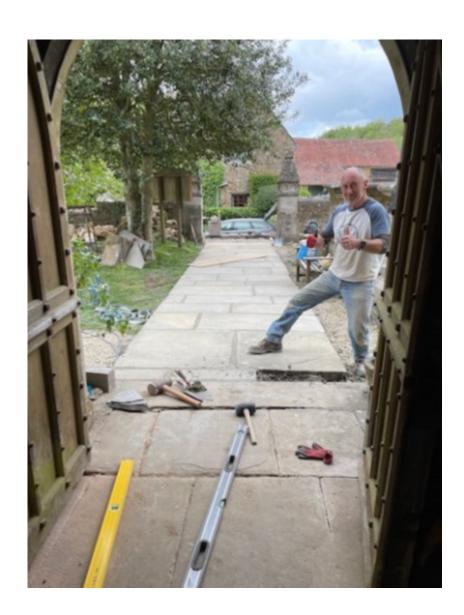
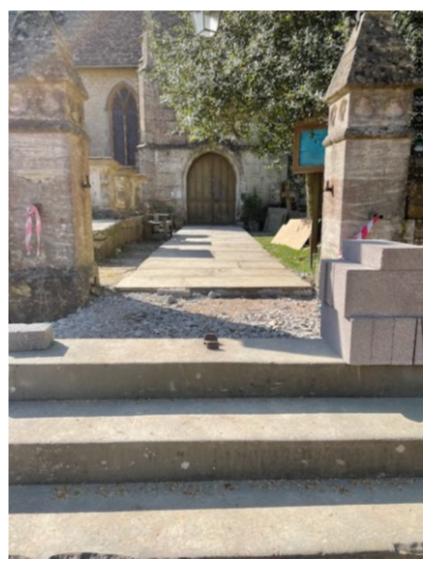
The last small slab was ceremonially set down by Ian to form the final piece of the jigsaw.

One of the additional tasks to make the path complete was to tie in the existing path up to the graveyard with the new path. Doug laid two small slabs and concreted a joint in the same style as the existing path.

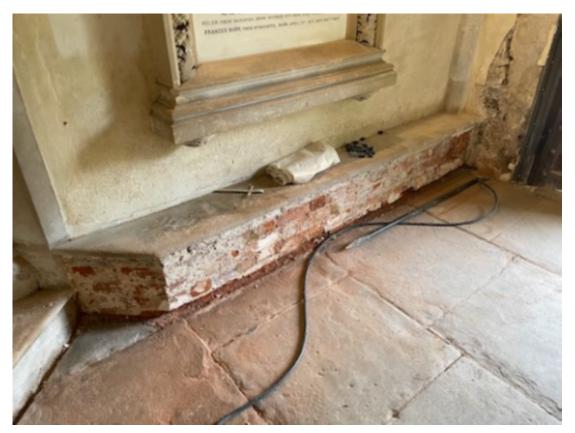
✓ The flaking lime render was removed on the low wall in the porch where the new armoured cable is to be channelled. Once the cable is hidden in the groove, the wall will be re-skimmed with fresh lime mortar.

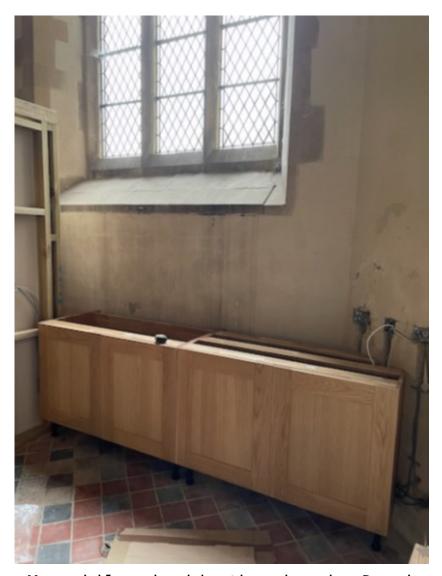
✓ The new worktops, sink and solid oak kitchen units were delivered on Tuesday and stacked in the church adjacent to the bell tower. The hole for the sink in the longest worktop was already partly cut out to avoid cracking and will need to be completely

removed and the edges finished before assembling the sink underneath.

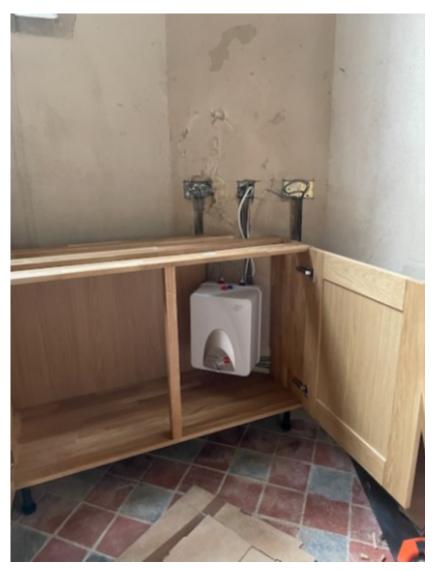
✓ Meanwhile, inside the church, Derek and John continued with the plumbing. The new water heater was positioned on the corner wall where it will be enclosed in one of the kitchen units. This unit was adapted to accommodate the 45 degree angled wall.

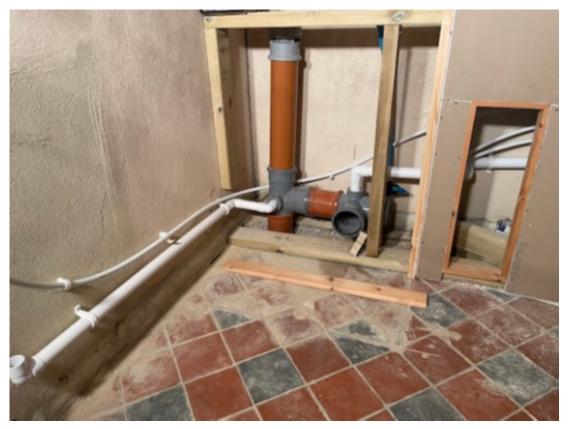
✓ The pipework for the cold water supply to the heater and kitchen sink taps was fitted with all the associated joints and bends. The hot supply and waste was also attached to the wall and fed through to the area behind the toilet. Simultaneously, the water supply and waste to the hand basin in the toilet were fitted. Final wooden linings were fitted to the openings behind the toilet in readiness for plastering.

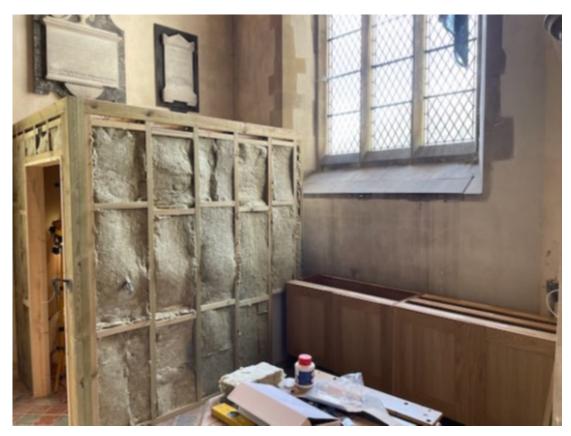
✓ Sound insulation was cut and fitted between the timbers of the ceiling and walls of the toilet cubicle. The outside walls will be clad in oak faced plywood with solid oak tracery, but only after the plastering has been accomplished.

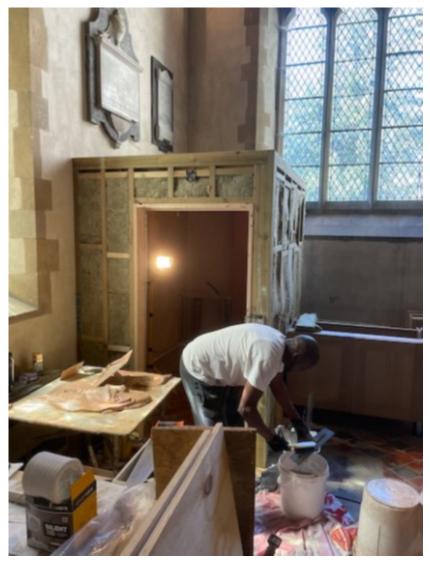
✓ Saturday saw Jacko from Overend Barn skimming the

plasterboard in the toilet cubicle.

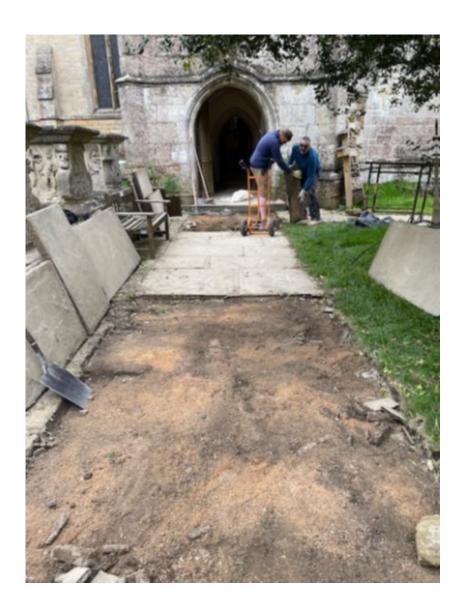
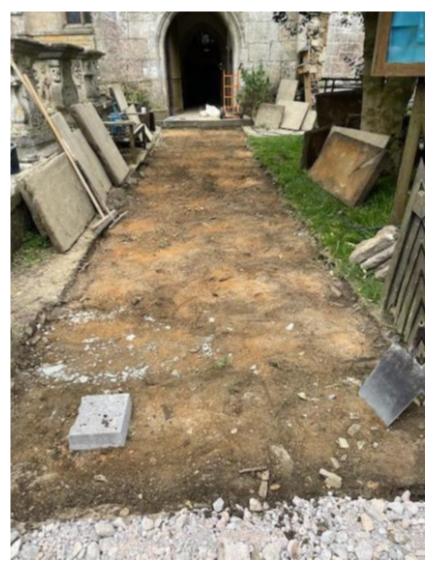
✓ Having now repositioned the front steps it was clear that all of the stone slabs leading from the gates to the porch will need to be lifted and re-laid higher to accommodate the new landing level by the gate posts and incline slightly up to the porch such that there will be no step to negotiate when entering the porch.

Jon and Doug carefully lifted each stone slab, marked them with a letter and a plan made of their positions so that they could be re-laid in exactly the same order.

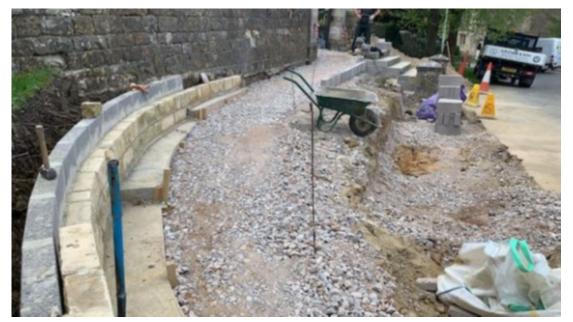
Jon and Doug barrowed Type 1 stone chippings from a delivery by the roadside and laid to form a slight gradient up to the porch threshold. A laser was used to confirm the incline angle. The gravel was finally compressed with a vibrating plate before the slabs will be relaid next week.

✓ The remainder of the gravel was deposited on the ramp and again compacted ready for the slabs to be laid on top.

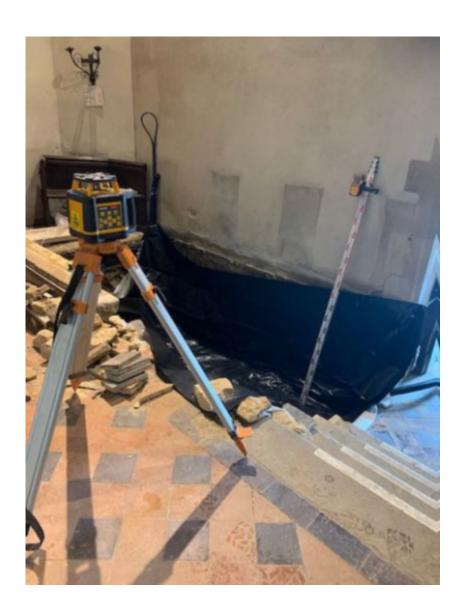
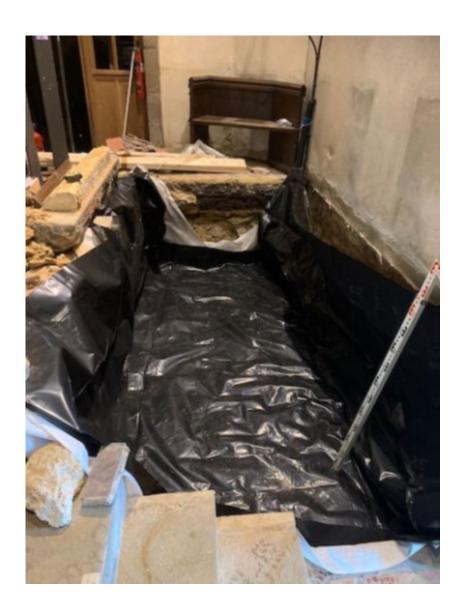
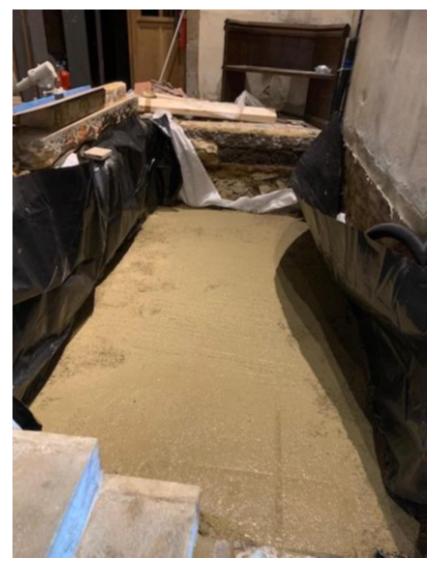
✓ Meanwhile, inside the church, Will inserted a damp proof membrane in the lift well before the sub floor was laid. A laser was used to confirm the precise depth such that reclaimed tiles could be laid to match the existing floor level, on top of a lime screed. A plastic conduit was first positioned adjacent to the existing church wall to carry the electric cables that are necessary for the lift and to take power to the lights on the ramp outside.

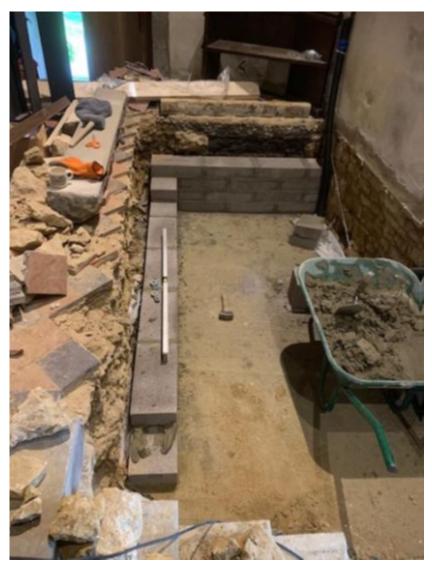
Once the mix had cured, Will laid new concrete blocks to form the retaining walls around the lift enclosure.

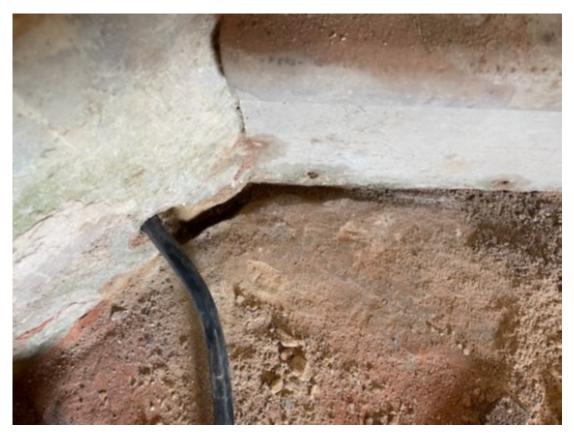
✓ Armoured electric cable was threaded through a small, drilled hole in the stone wall adjacent to the steps up to the parvis room, to take the wire through the porch to the outside. The cable will be hidden in a groove cut into the bottom of the wall in the porch and then secured in place with lime mortar. At the same time, the flaking render on the lower walls of the porch will be removed and re-skimmed with lime mortar.

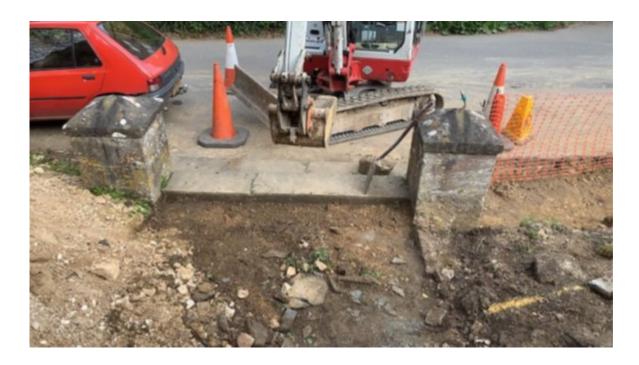
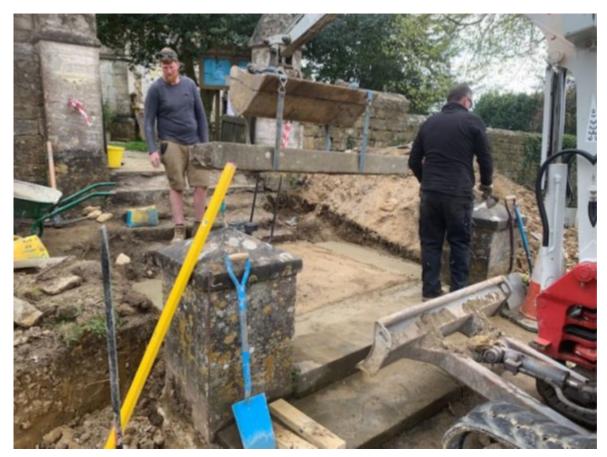
✓ The week started with the repositioning of the stone steps to make space for the new disabled ramp.

The two lower steps were fixed in place and the restraining concrete block walls were constructed before laying the upper treads.

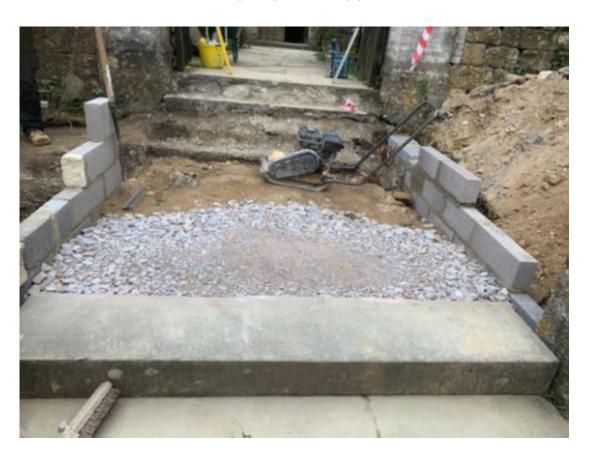
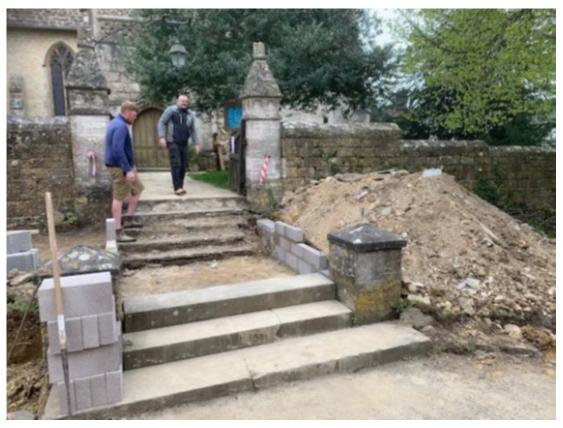
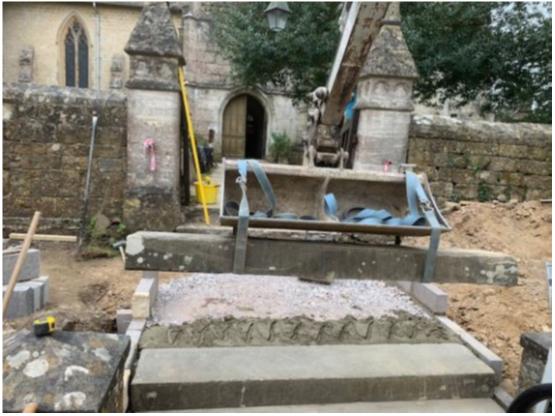
By the end of the week all five treads had been replaced. The original steps had slightly sunk over time such that they were tilting backwards. This had the unfortunate result of holding any rainfall at the back of the treads. Having now repositioned the steps correctly has consequently increased

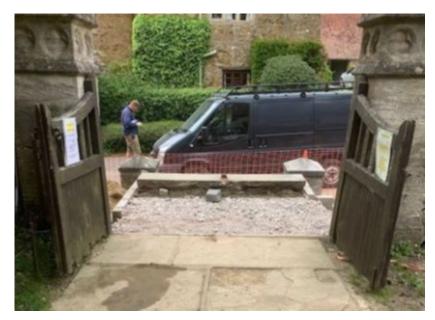
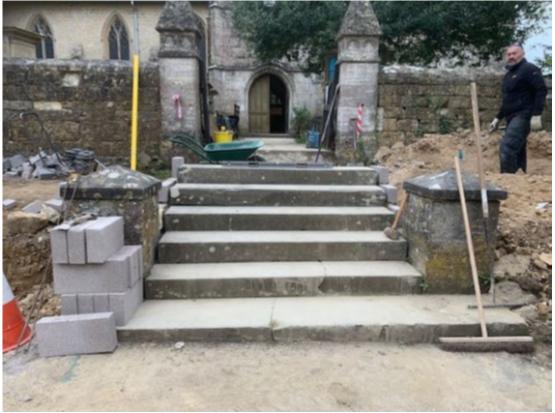
the overall height slightly, causing the top step to be higher than the path.

The path was to have been raised slightly anyway to form a slight ramp up to the porch entrance, but it has meant that the bottom hinges for the gates will need to be removed and positioned higher.

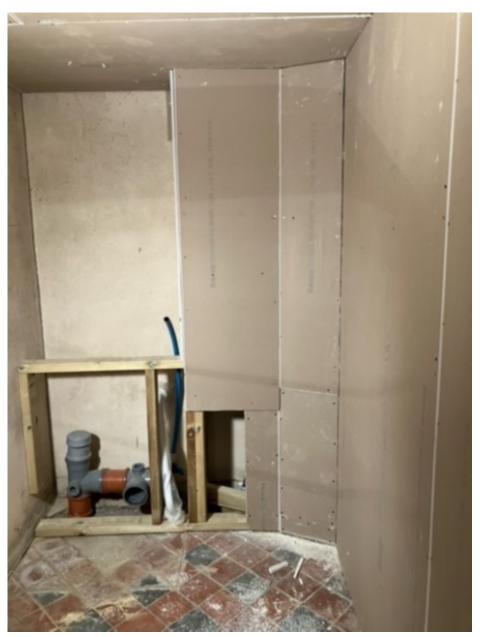
✓ Meanwhile inside, Derek continued fixing two layers of plasterboard to the rear walls of the toilet cubicle, which

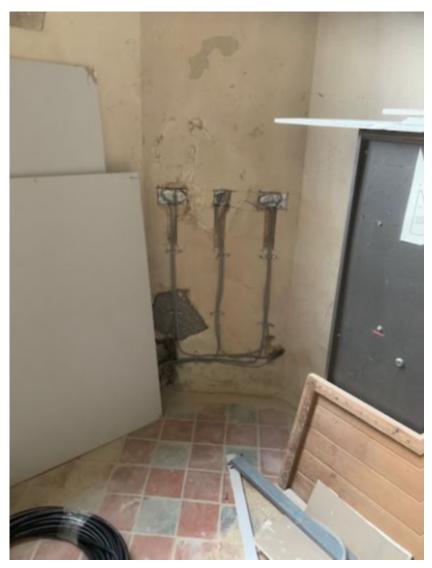
✓ Simon Beisly, the electrician, began the first fix this week, which included locating wiring for the sockets and switches in both the toilet and kitchen areas.

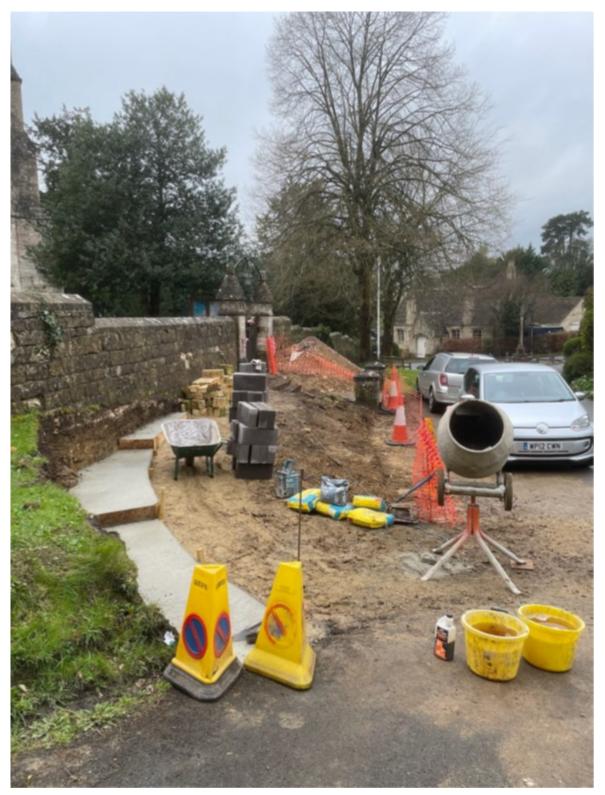
✓ Concrete was mixed on site and poured into the three spaces between the shuttering that was installed at the end of last week. The three sections are to accommodate the incline, which will form the edging to the disabled ramp.

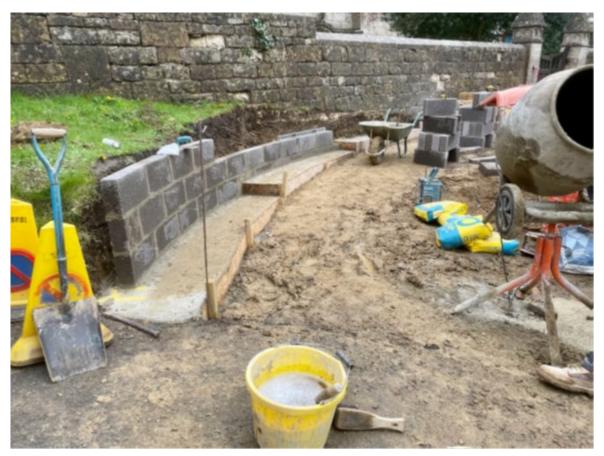
✓ A more accurate arc was plotted on the new concrete foundations to form the building line for a double wall comprising concrete blocks at the back and solid dressed stone for the facing.

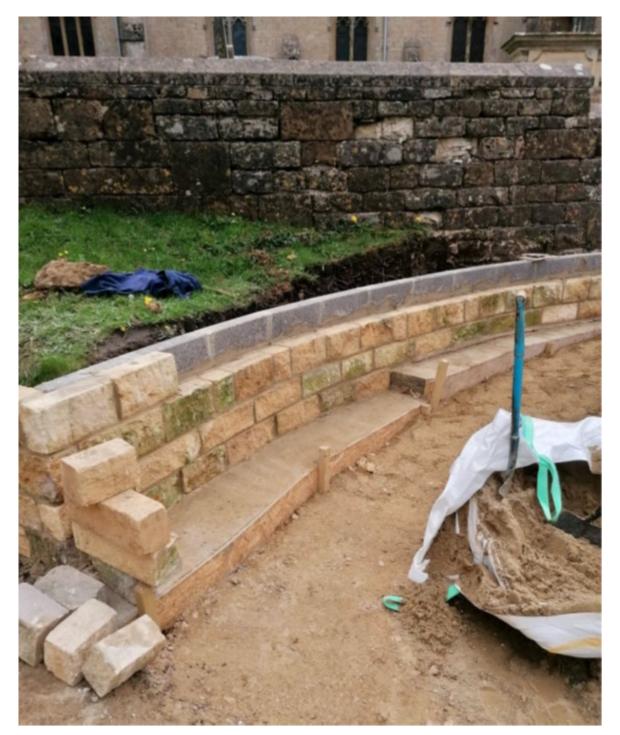
✓ Dressed Cotswold stone blocks were laid in front of and tied into the concrete blocks to form the final facing of the wall. A small return (corner) was created to finish off the wall where it meets the tarmac path up to Church Cottage.

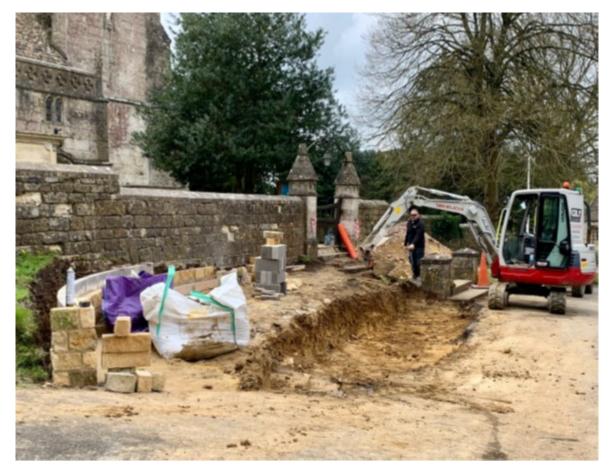
✓ More clay at the abutment with the road was removed with the digger to provide a wider parking space for a hearse or disabled vehicle. This area will be dug down 20cm lower than the road, and filled with Type One (gravel) to form a base for tarmac, which will extend the width of the road.

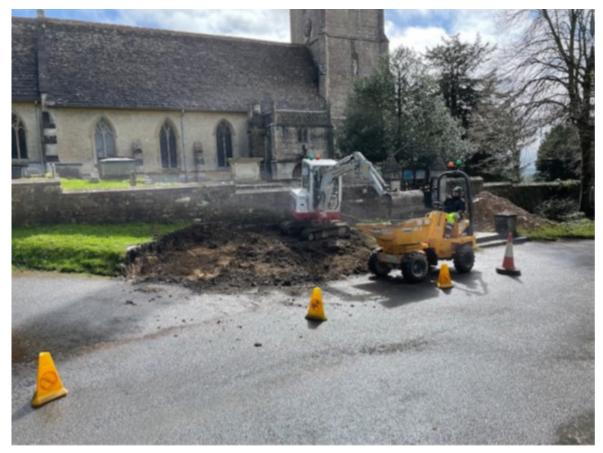
✓ A digger and dumper truck arrived on site and work started by removing the old tree stump.

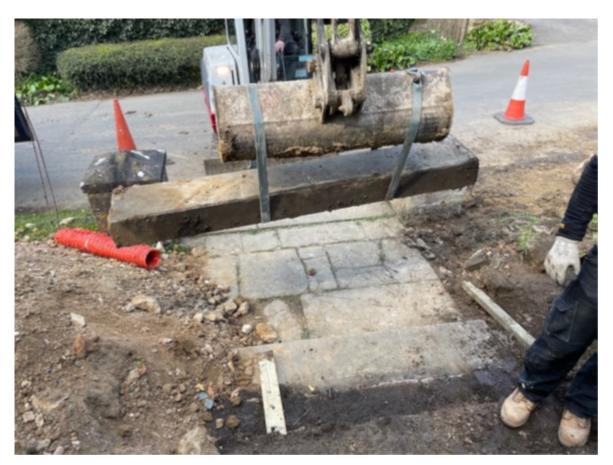
- ✓ Soil and clay were dug out of the left bank, adjacent to the north entrance steps and deposited temporarily in the church field.
- ✓ The stone steps were loosened and gently transported to rest in the church field until the site is ready to reposition them.

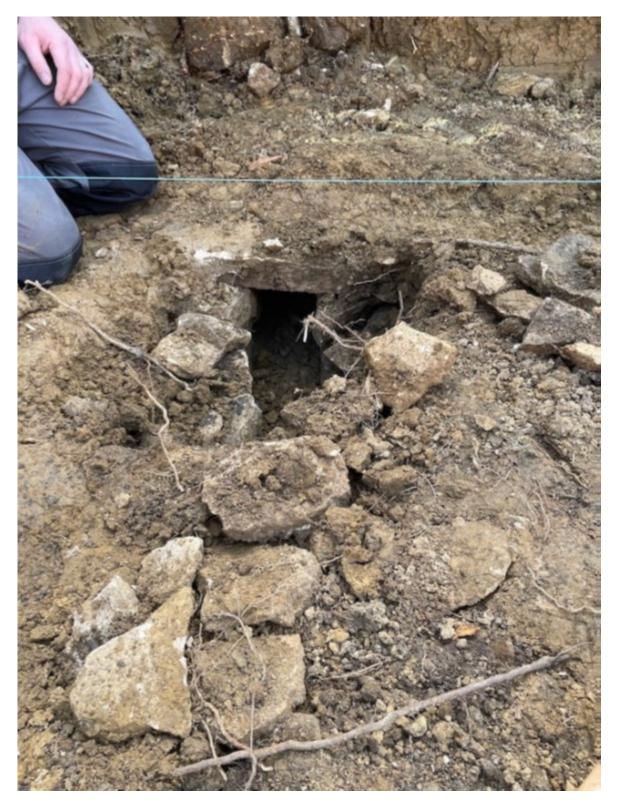
✓ Using a laser, the levels for the ramp were set out prior to construction work. The radius for the ramp was marked out taking into consideration the low walls on each side of the path. At this point, whilst driving in a peg to support the shuttering, Will

discovered yet another drain! This one ran in the direction of Church Farmhouse and was damp, suggesting it is still operational. The covering stones were carefully replaced after inspection and recorded by camera.

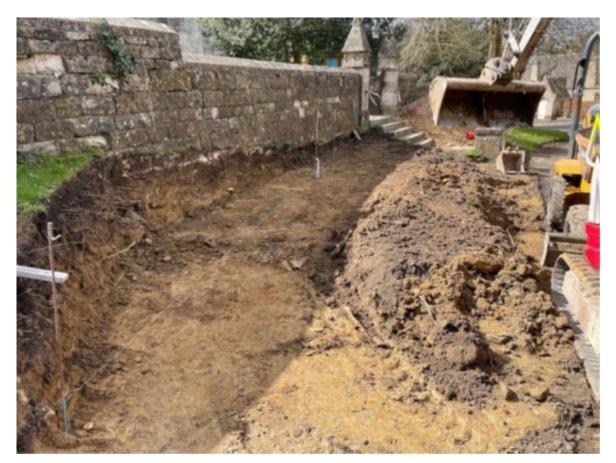
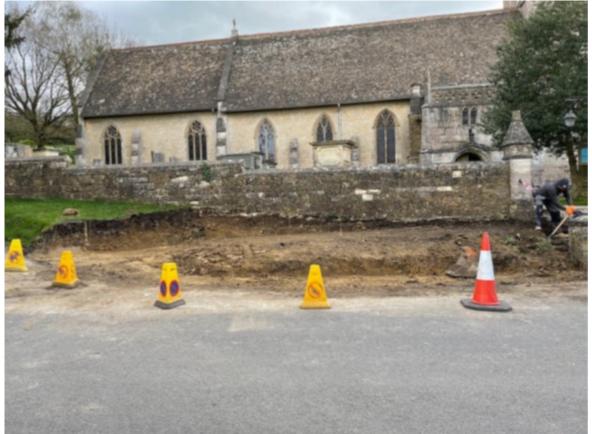
✓ A line was set up to mark the gentle slope of the disabled ramp, and surprised us that the gradient was finally recorded at only 1 in 25, where 1 in 12 is the maximum slope. Two horizontal landings were included because there has to be one at the

start of the ramp, and the regulations dictate that a resting place must be included every five metres, hence we have included another halfway up the slope.

✓ Shuttering was set up to form a framework into which concrete will later be poured for the foundations of the low walls. More concrete will be poured behind the low walls to underpin the existing stone wall above. The existing

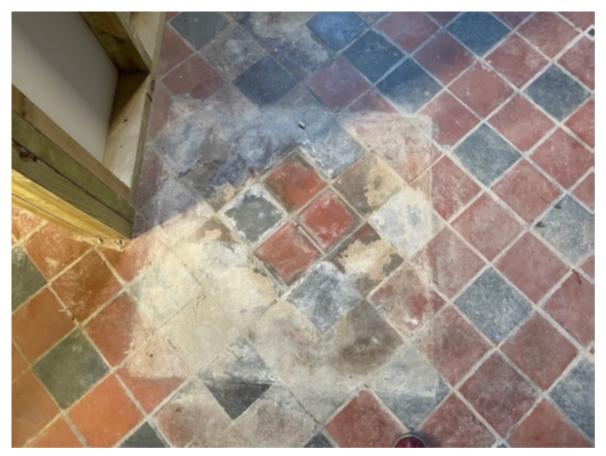
✓ The hole under the font was filled-in and re-tiled using four redundant original tiles from the back of the toilet and secured with lime mortar and grouting. The residual cement mortar that was used to fix the font in place will be removed with brick acid.

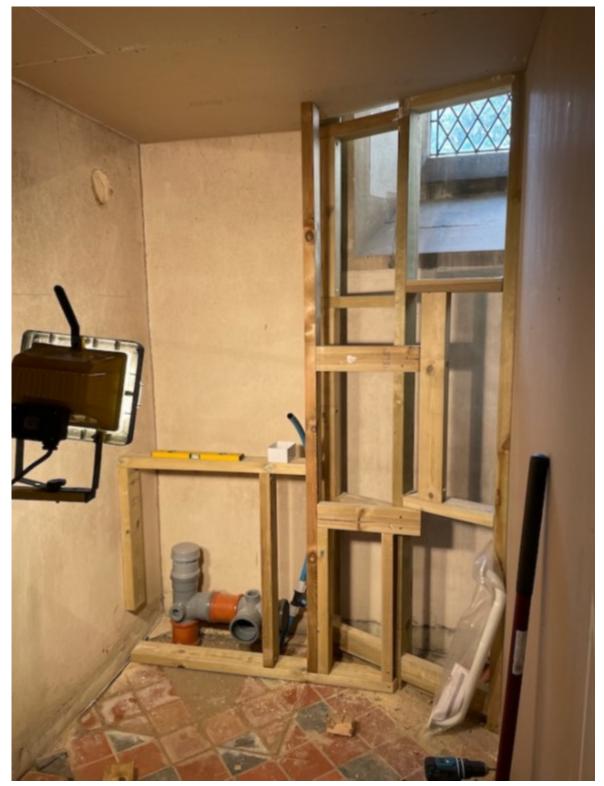
✓ Time was spent discussing and designing the plumbing system for the toilet and kitchen and the effect this will have on the studwork and plasterboard behind the toilet. A small cupboard will be included to allow access to the water stop tap. Similarly, the hole in the toilet floor was filled in and re-tiled using lime mortar.

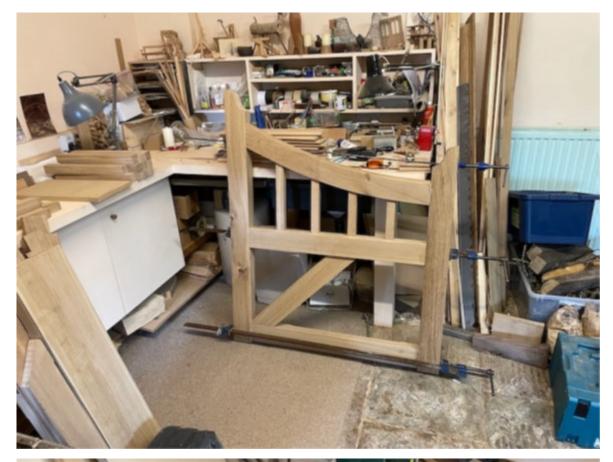
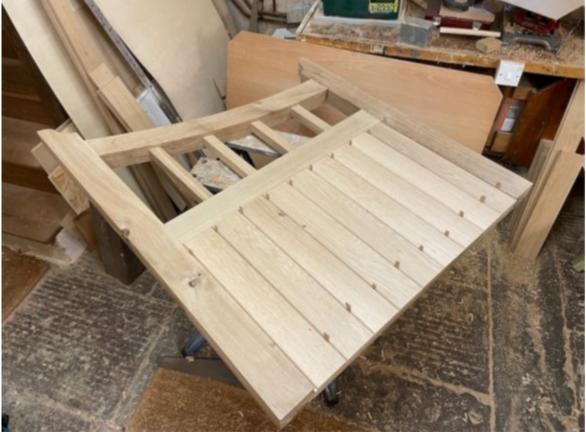
- ✓ Derek carefully removed the hinges on the internal arched door with the help of an impact driver. It was decided to fit a new lock and door handles once the door is rehung to open in the opposite direction into the church.
- ✓ Derek, with John in his workshop have made good progress during the week, cutting the oak tongue and groove and gluing together the first of four new gates. Work also continued

cutting the mortise and tenon joints on the second gate.

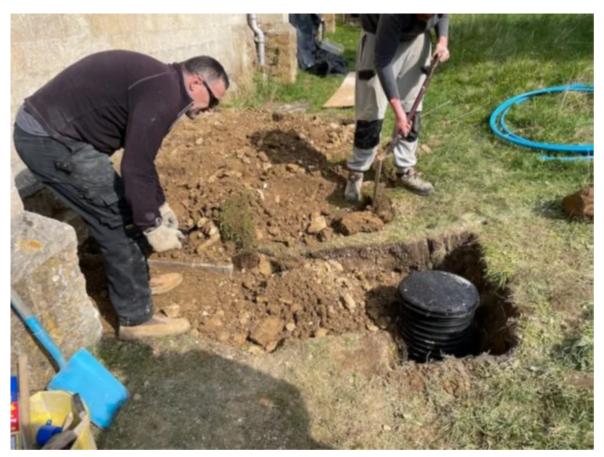
- ✓ A connection to the existing water pipe was made in the trench outside, by first isolating the supply at the stop tap in the road.
- ✓ A new stop tap was positioned where the blue water pipe emerged through the hole in the wall, and above ground level in the toilet area.
- ✓ An inspection chamber was concreted and installed in the trench above the gas pipe. The ground was filled in around it, leaving just the lid of the inspection chamber visible. The trench arch will be eventually excavated from this position

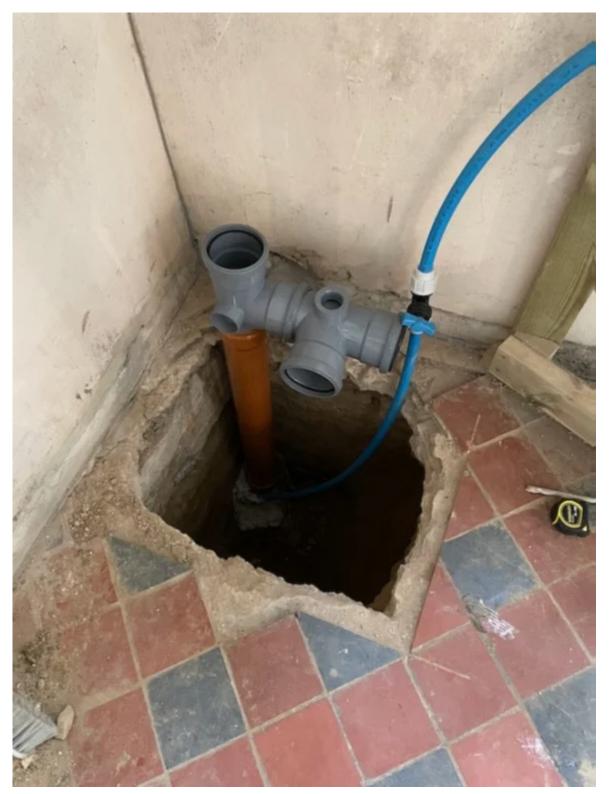
✓ The associated pipes and bends from the back of the toilet and basins was arranged in the corner of the toilet area. Type 1 (gravel) was tipped in the hole with some of the original spoil to a level 100mm below finished inside floor level. Limecrete will be laid to bring the final level up to 25mm below floor level to enable the floor tiles to be relocated.

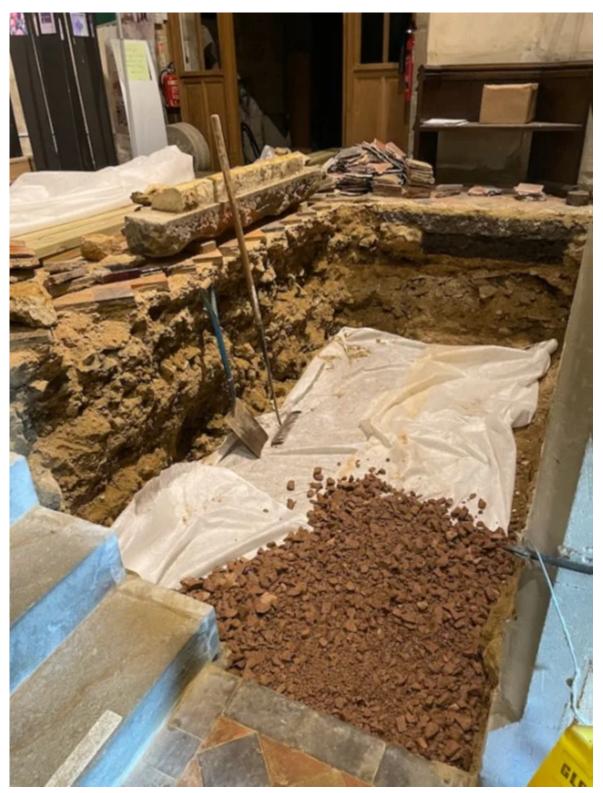
✓ Following a second visit from the archaeologist on Monday, more bone specimens were inspected as well as the ancient trench that was discovered in the lift well at the end of last week. Seemingly, it is of no great significance, and so the ground in the lift area continued to be excavated to a depth of 30cm below the existing threshold tiled floor level and tube covered with a geotextile fabric. More Type 1 was then barrowed and tipped in bringing the level up to 21cm below

final floor level. The gravel was compacted with a vibrating plate, before covering with 12 cm of limecrete.

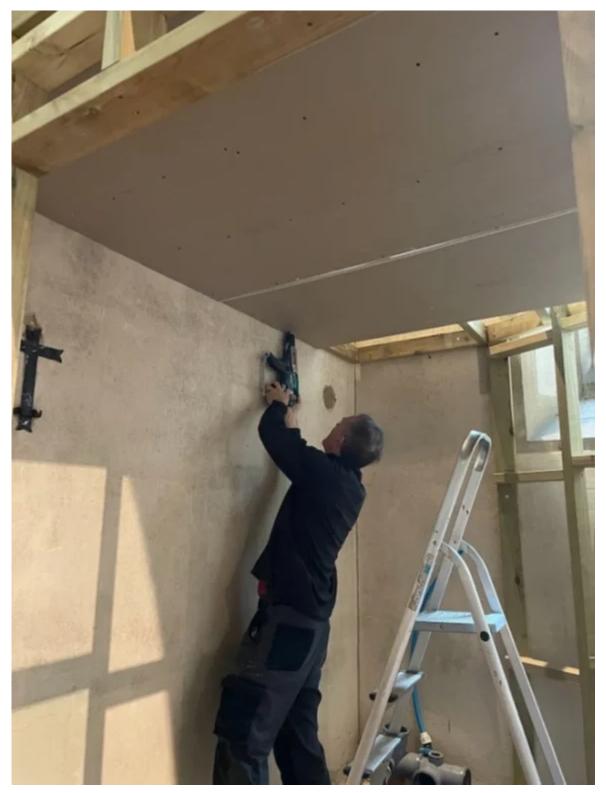
✓ The walls and ceiling of the toilet cubicle were clad with two layers of plasterboard, but the cavity left for the electrician to do a first fit of the wires and trunking that will happen on 13 April.

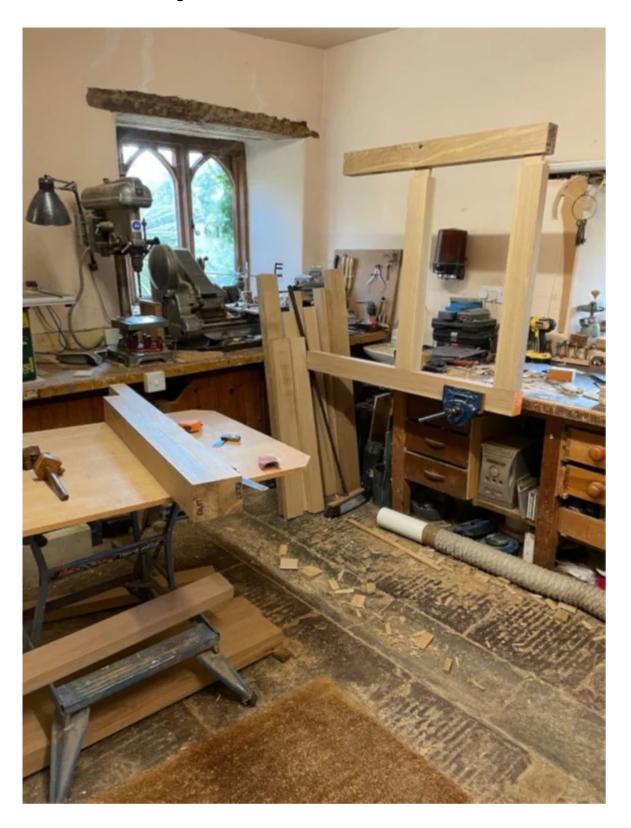
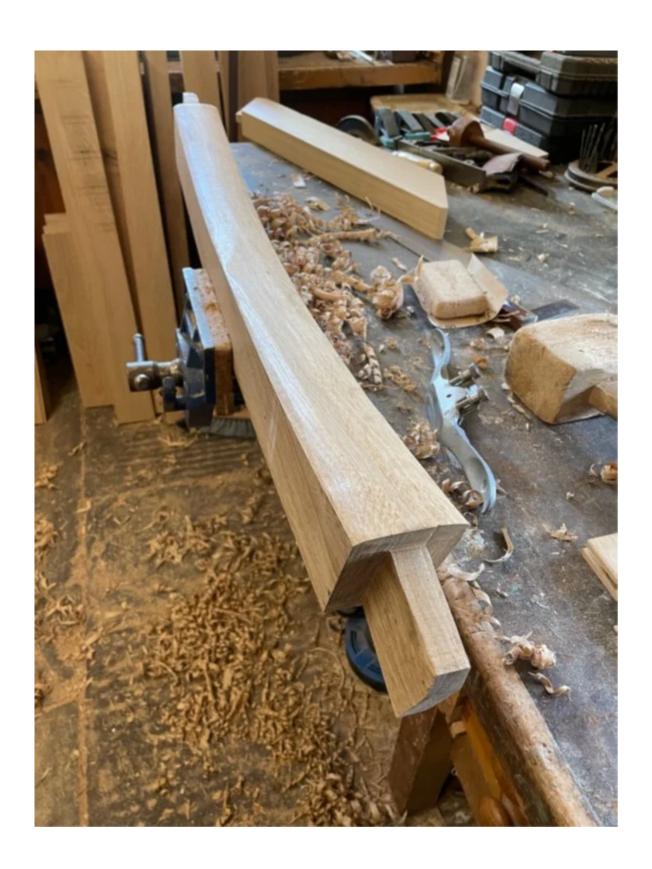
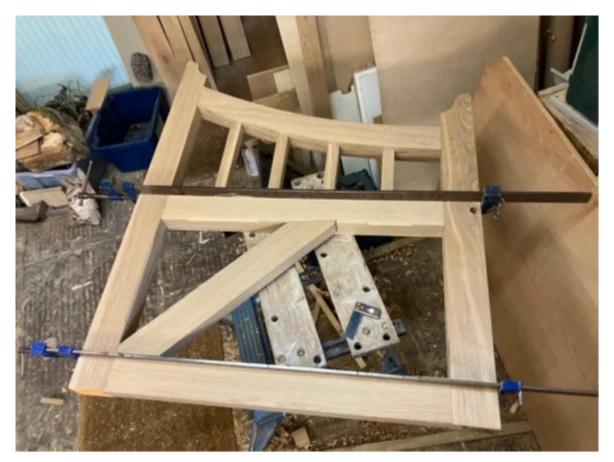
✓ Derek, with John in his workshop have made good progress during the week, where they are making a new set of oak gates for the re-designed north entrance.

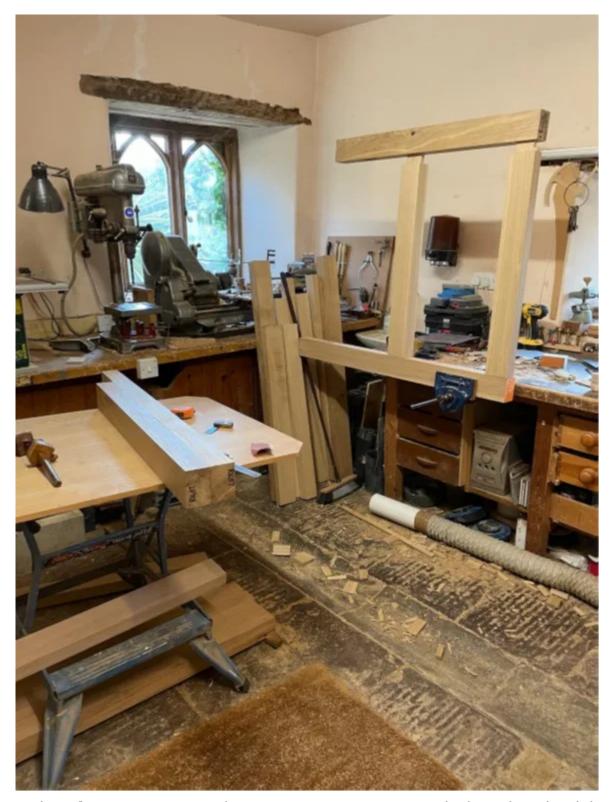
✓ With the help of Derek, the pair of us cut some of the mortise and tenon joints that will form the pair of new oak gates for the north entrance.

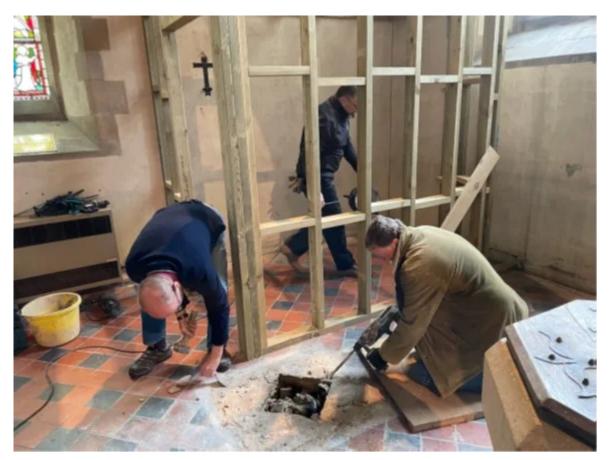
✓ The font was moved to a temporary position by jacking it up and inserting steel rollers beneath. A 12" square hole was revealed beneath and we have shown the archaeologist the discovery. Some of the stones that were used to fill the void were interesting. One piece, in particular looked like it was carved to form a boss from a vaulted ceiling. Another couple of pieces of stone were dressed and showed signs of soot. My

theory is that the roof of the parvis room might have once been stone vaulted before replacing it with a wooden structure and covered in lead. There is still a short chimney stack, indicating that a fireplace was part of the east wall. I believe the small stones we found under the font were redundant parts from this refurbishment. Russell and Roger worked on cleaning up the tiles after moving the font.

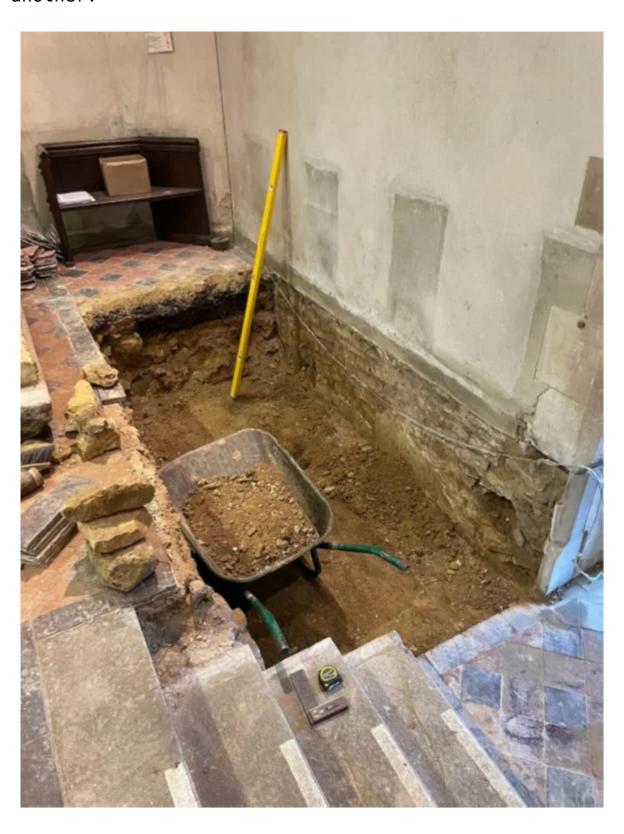
✓ Will, and his two employees Jon and Doug, used machinery to remove the ceramic tiles and limecrete that I laid on the rubble floor over twenty years ago when myself and a team of villagers removed the seven short pews by the bell tower.

Fortunately, limecrete is not as difficult to remove as the much harder concrete might have been. An area approximately 3M x 1.4M was dug by hand and the spoil tipped on the grass on the right of the north front approach steps. One or two small pieces of bone were discovered as well as remnants of cut and faced stone that had been previously used for one reason or another.

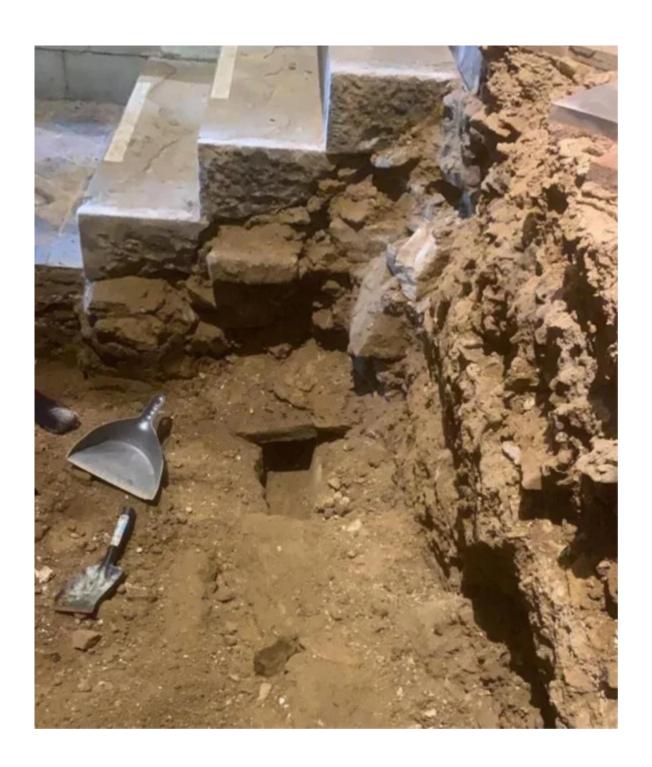
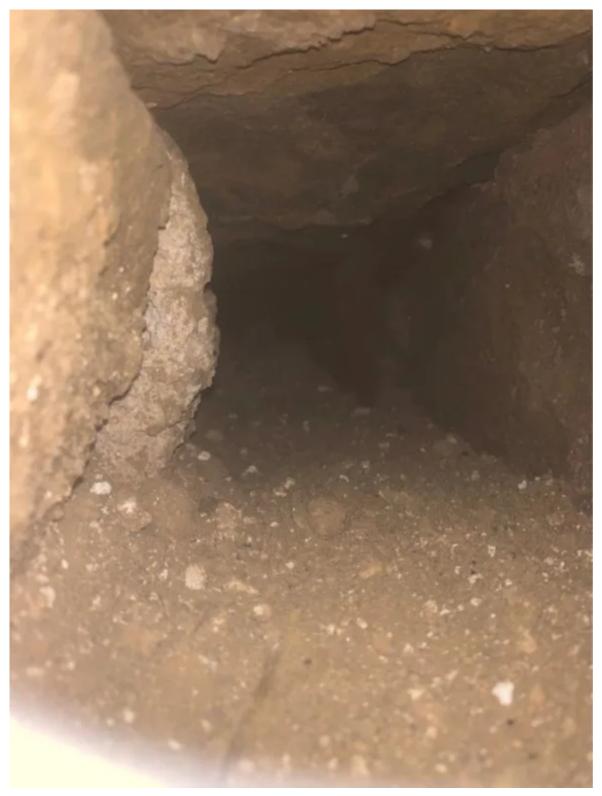
Digging to a depth of 30cm below existing porch floor level, Will discovered a small flat cut piece of stone. Upon lifting the stone, he discovered a stone trench, or culvert of approximately 25cm square cross-section. Knowing that the porch is the oldest remaining part of the church, and that the floor level of the main section of the church was raised, this culvert would have been just below ground level. However, it is more interesting that it continues on a curve, passing beneath the steps up to the belfry. Hence, it must be rather old. Richard, the archaeologist is anxious to inspect this discovery when he visits again next Monday.
